REPORT OF AIRCRAFT ACCIDENT

(1) Place 3/4 mile west Moody Field, Ga. (2) Date 16 March 1944 (3) Time 01:50Z
 AIRCRAFT: (4) Type and model AT-10 (5) A. F. No. 41-1751 (6) Station Moody Field, Ga.
 Organization: (7) AAFEFTC (8) None (9) 464th TEFTS
(Command and Air Force) (Group) (Squadron)

There is submitted a Committee report of accident investigation involving AT-10 airplane, AF No. 41-1751.

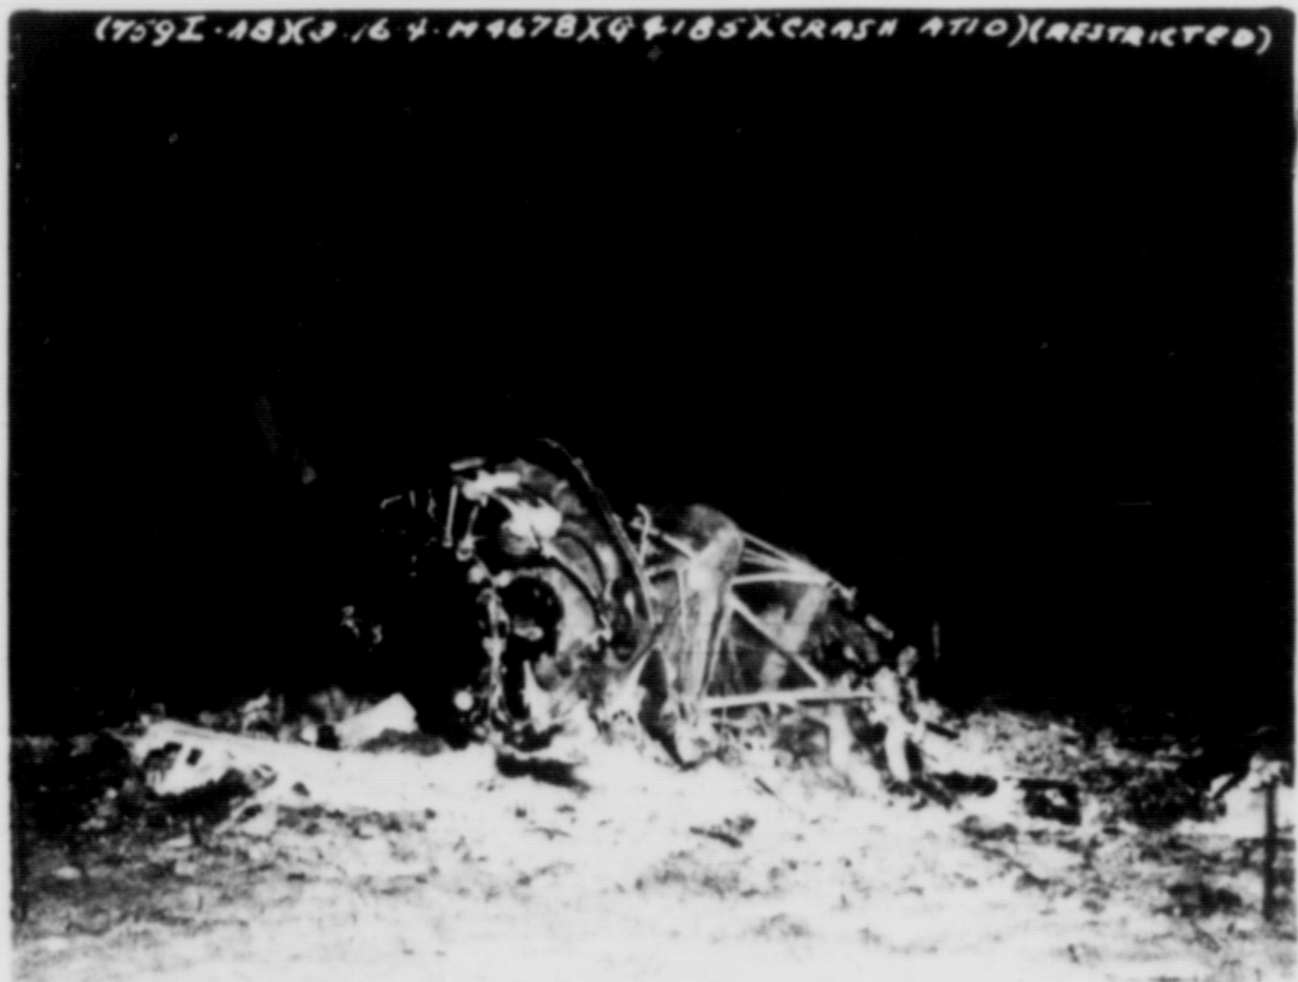
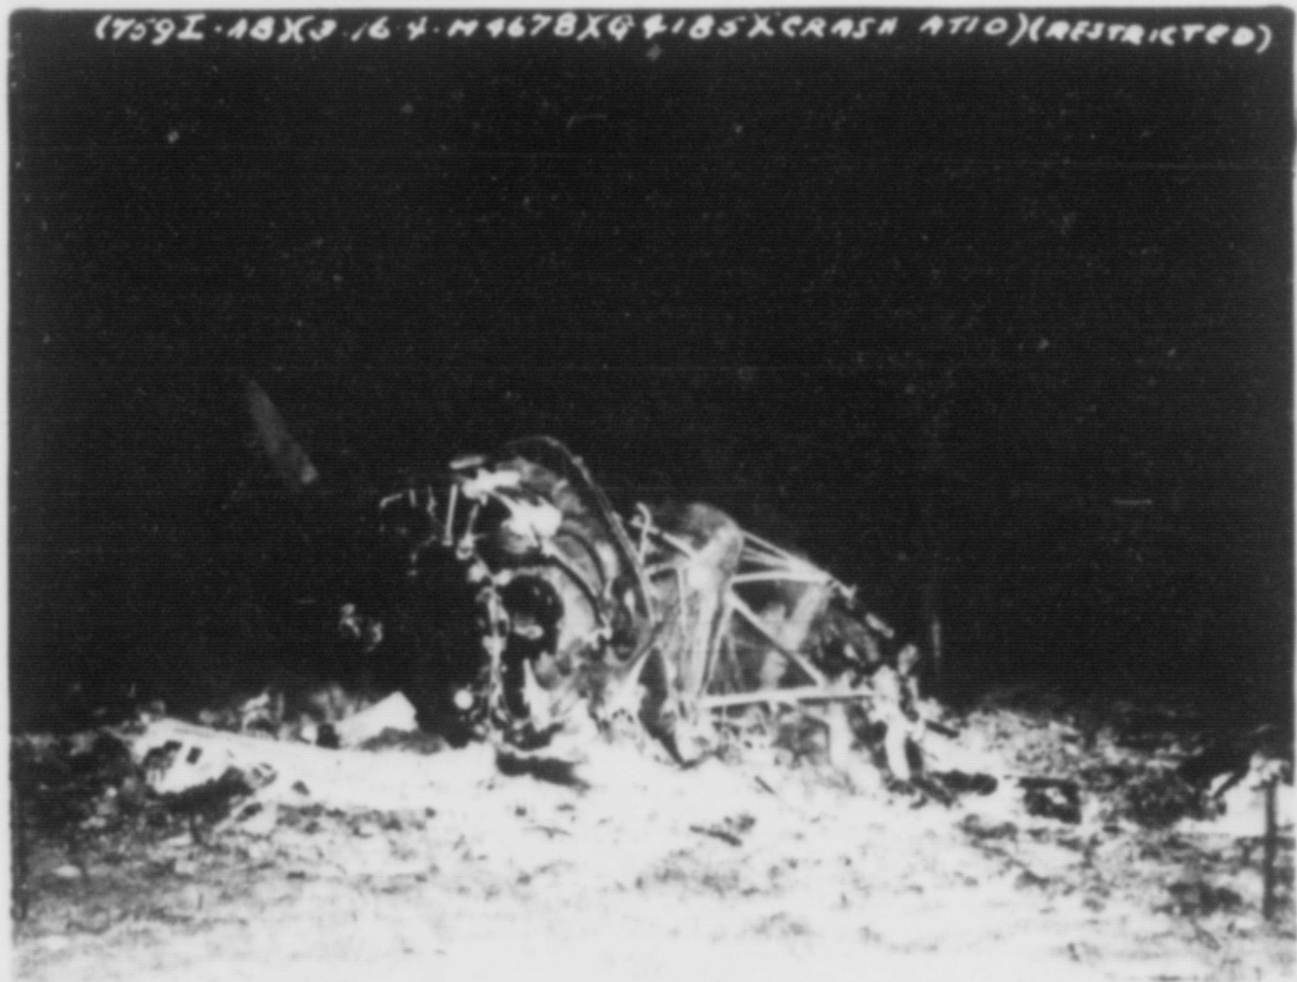
The airplane was completely destroyed by fire upon impact with ground after striking several trees. The engines were severely burned; but upon tear-down inspection, the adapter assembly fuel pump drive on left engine was found to be broken. With cross-feed in "off" position, the failure of this part would leave only the gas remaining in the carburetor to be burned before engine stopped. Furthermore, this part would have had to break after take-off run was started; otherwise, engine failure would have occurred before ship reached take-off position. Standard procedure at this station is for cross-feed to be in "on" position before take-off. It appears that failure of this part was probably caused by impact at time of crash.

At approximately 21:50 o'clock, 16 March 1944, airplane AT-10BH, A.A. F. No. 41-1751, crashed and burned 3/4 mile west of Moody Field, Georgia. The airplane and both engines were damaged beyond repair. It is requested that airplane and both engines be surveyed in accordance with A.A.F. Regulation 65-43.
